**Flood Control Project Maintenance
Levee Inspections**

Maintenance Issue Types Only, Levee Inspection Report By Mile - Spring 2018

Reclamation District No. 0010 Honcut

Waterway	Bank	Unit Miles	Inspection Start/End	Inspector
Unit No. 01 Simmerly Slough	Right	7.65	04/10/2018 04/10/2018	Sterling York

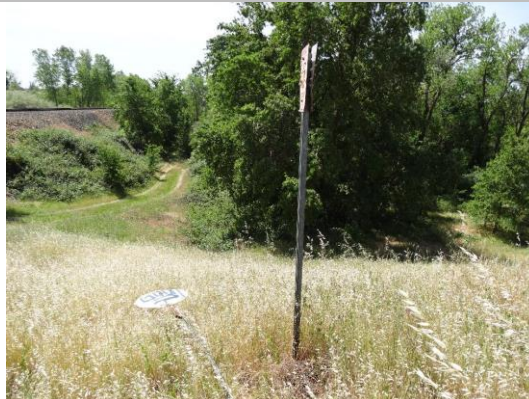
Photo 2 of 3 : UCIP_SP_2018_27791_51500.jpg

Pipe marker visible on ground--sign has been bent.

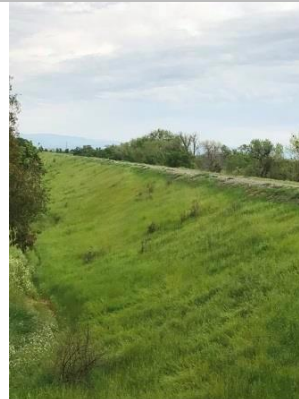
Photo 1 of 1 : SP_2018_RD0010_163_1_20180411_00093.jpg

LM Start	0.00	Rating **	A	Issue No.	1
LM End	1.36	Issue Type +	Ma	Location *	LS
Category	Earthen Levee			GPS Latitude/Longitude	
				Start	End
Item	Vegetation			39.163724 °	39.168775 °
				-121.609935 °	-121.590443 °
DWR ID	DWR_RD0010_01_s_2018_1				
Comment Code					
V1 : Control annual grass and weeds on the levee slopes and easements.					
Inspector Comment					
Annual vegetation is maintained, Spring 2018.

View looking upstream landside of maintained annual vegetation, Spring 2018.

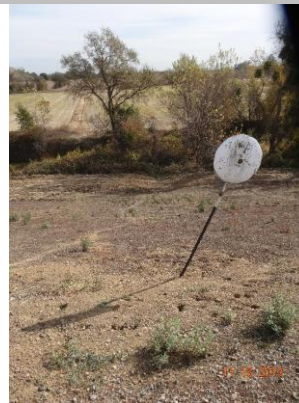
Photo 1 of 3 : UCIP_SP_2018_27748_51453.jpg

FS_ID:27748
DS_ID:21261
EP_NO: N/A
Repair Type: No Action Needed
Crossing Status: Found
UCIP Comments: No signs of damage to levee present during inspection. This crossing is referenced in the USACE Periodic Inspection as item USACE_CESPK_HON1_2013_p_0037 and 0040.
FIELD_STRUCT_DESC: 24-inch corrugated metal gravity drainage pipe through the levee, 29.5 feet below the crown. Two corrugated metal cutoff walls around the pipe on each end. Slide gate on the landside (LS) end. Flap gate on the waterside (WS) end. Concrete headwall at the LS toe. [Additional Reference(s): DWR Levee Log, 2005. USACE Sacramento O&M Manual 151, May 1953, (Station 37+66)].
FS Date: 4/29/2013

View of waterward side--slope and marker for pipe crossing.

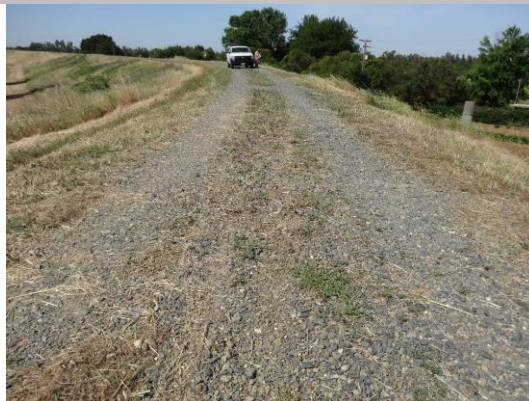
Photo 1 of 3 : UCIP_SP_2018_24811_44582.jpg

FS_ID:24811
DS_ID:21264
EP_NO: N/A
Repair Type: No Action Needed
Crossing Status: Found
UCIP Comments: This crossing is referenced in the USACE Periodic Inspection as item USACE_CESPK_HON1_2013_p_0004.
FIELD_STRUCT_DESC: [Reclamation District No. 10 (RD0010) Drainage Plant] 16-inch steel drainage discharge pipe through the levee, 7 feet below the crown. Steel cutoff plate around the pipe at the center of the levee. Siphon breaker on the landside (LS) slope. Flap gate on the waterside (WS) end. Pump in a pit at the LS toe with steps along the LS slope. Saddle and 8-foot splash apron at the discharge end of the pipe. Concrete headwall at the LS toe. Metal shed on the LS slope. [Additional Reference(s): DWR Levee Log, 2005. USACE Sacramento O&M Manual 151, May 1953, (Station 13+88)].
FS Date: 4/29/2013

View of levee crown looking upstream of crossing.

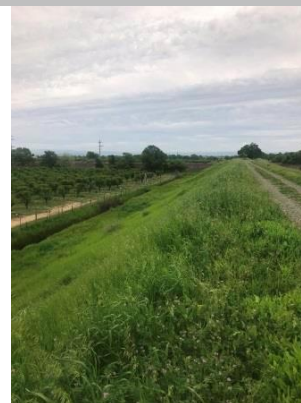
Photo 1 of 1 : SP_2018_RD0010_163_38_20180411_00100.jpg

LM Start	1.36	Rating **	U	Issue No.	38	
LM End	7.64	Issue Type +	Ma	Location *	LS	
Category	Earthen Levee			GPS Latitude/Longitude		
				Start		End
Item	Vegetation			39.168803 °		39.256072 °
				-121.590318 °		-121.574945 °
DWR ID	DWR_RD0010_01_s_2018_38					
Comment Code						
V1 : Control annual grass and weeds on the levee slopes and easements.						
Inspector Comment						
Annual vegetation is over grown, Spring 2018.

View looking upstream landside overgrown annual vegetation, Spring 2018.

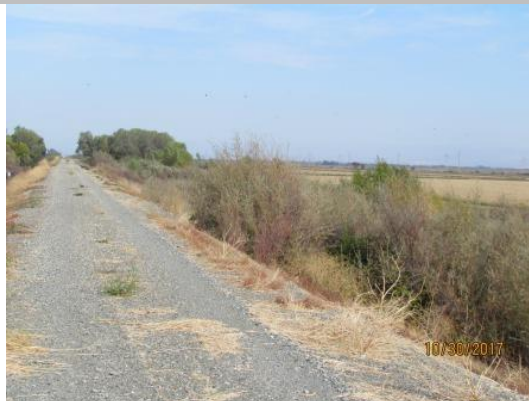
Photo 1 of 1 : SP_2018_RD0010_163_35_20180302_00009.jpg

LM Start	2.70	Rating **	M	Issue No.	35
LM End	2.70	Issue Type +	Ma	Location *	WS
Category	Earthen Levee			GPS Latitude/Longitude	
				Start	End
Item	Trim / Thin Trees			39.184974 °	39.184974 °
				-121.583836 °	-121.583836 °
DWR ID	DWR_RD0010_01_f_2017_35				
Comment Code					
T2 : Thin trees to allow visibility of the ground and room to flood fight.					
Inspector Comment					
Willows on levee slope need to be removed, Fall 2017.

View looking upstream waterside at Willow Trees that need to be removed, Fall 2017.

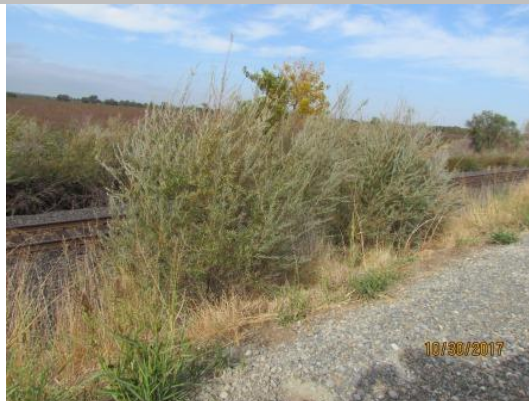
Photo 1 of 1 : SP_2018_RD0010_163_37_20180302_00012.jpg

LM Start	4.83	Rating **	M	Issue No.	37
LM End	4.83	Issue Type +	Ma	Location *	LS
Category	Earthen Levee			GPS Latitude/Longitude	
				Start	End
Item	Trim / Thin Trees			39.215597 °	39.215597 °
				-121.580046 °	-121.580046 °
DWR ID	DWR_RD0010_01_f_2017_37				
Comment Code					
T3 : Trim and thin trees to allow visibility of the ground and room to flood fight.					
Inspector Comment					
Small willow tree on landside slope should be removed. Fall 2017.

View of small willow trees on the landside slope looking upstream. Fall 2017.

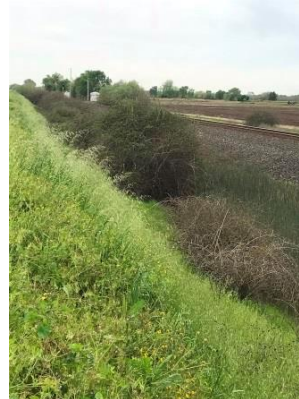
Photo 2 of 2 : SP_2018_RD0010_163_36_20180411_00103.jpg

LM Start	6.18	Rating **	M	Issue No.	36 (cont)	
LM End	6.34	Issue Type +	Ma	Location *	LS	
Category	Earthen Levee			GPS Latitude/Longitude		
				Start		End
Item	Vegetation			39.235067 °		39.237286 °
				-121.577541 °		-121.577218 °
DWR ID	DWR_RD0010_01_s_2016_36					
Comment Code						
V2 : Remove the wild growth other than native grasses from the levee slopes.						
Inspector Comment						
Large cluster of willows and wild rosebushes on landside slope and toe. Spring 2018.

View looking downstream landside of willows and wild rosebushes that are blocking visibility on the slope, Spring 2018.

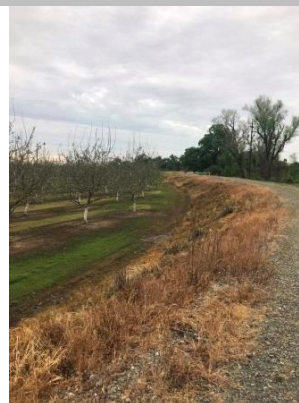
Photo 1 of 2 : SP_2018_RD0010_164_26_20180411_00101.jpg

LM Start	0.02	Rating **	A	Issue No.	26
LM End	11.32	Issue Type +	Ma	Location *	LS
Category	Earthen Levee			GPS Latitude/Longitude	
				Start	End
Item	Vegetation			39.163961 °	39.309530 °
				-121.610050 °	-121.616605 °
DWR ID	DWR_RD0010_02_s_2018_26				
Comment Code					
V1 : Control annual grass and weeds on the levee slopes and easements.					
Inspector Comment					
The annual vegetation is starting to get a little tall but is still maintained, Spring 2018.

View looking downstream landside of the well maintained annual vegetation, Spring 2018.

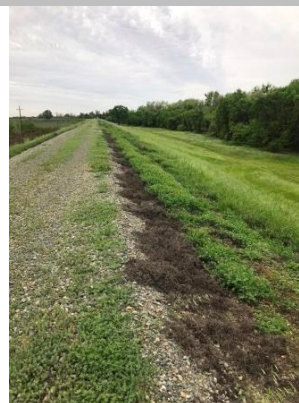
Photo 1 of 2 : SP_2018_RD0010_164_38_20180411_00106.jpg

LM Start	0.02	Rating **	A	Issue No.	38
LM End	11.32	Issue Type +	Ma	Location *	LS
Category	Earthen Levee			GPS Latitude/Longitude	
				Start	End
Item	Vegetation			39.163961 °	39.309530 °
				-121.610051 °	-121.616606 °
DWR ID	DWR_RD0010_02_s_2018_38				
Comment Code					
V1 : Control annual grass and weeds on the levee slopes and easements.					
Inspector Comment					
The annual vegetation is starting to get a little tall but is still maintained, Spring 2018.

Second view looking downstream waterside of the maintained annual vegetation, Spring 2018.

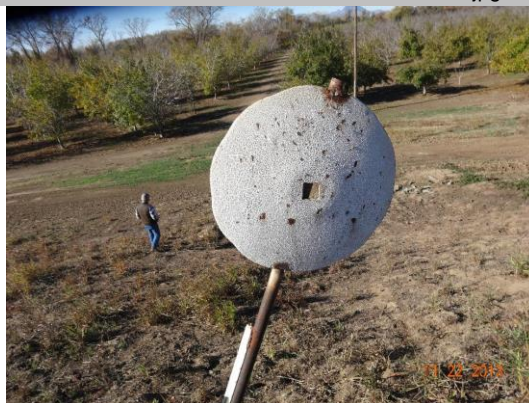
Photo 1 of 3 : UCIP_SP_2018_24825_44664.jpg

Marker visible on waterward side.

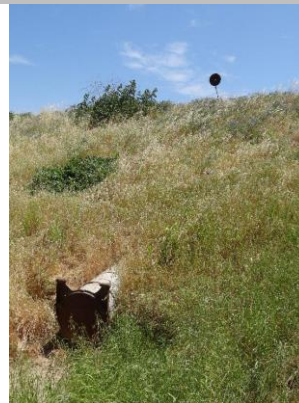
Photo 1 of 3 : UCIP_SP_2018_24751_44375.jpg

View of waterward side--dense vegetation on slope.

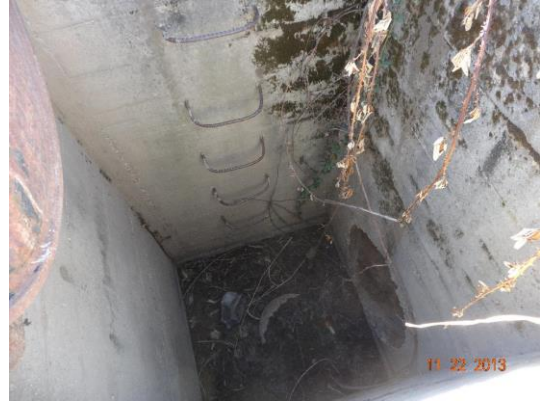
Photo 3 of 3 : UCIP_SP_2018_24828_44683.jpg

Comment Code					
Inspector Comment					
FS_ID:24828 DS_ID:21290 EP_NO: N/A Repair Type: No Action Needed Crossing Status: Found UCIP Comments: This crossing is referenced in the USACE Periodic Inspection as item USACE_CESPK_HON2_2013_p_0212. FIELD_STRUCT_DESC: 30-inch corrugated metal gravity drainage pipe through the levee, 20 feet below the crown. Corrugated metal cutoff wall around the pipe at each shoulder. Flap gate on the waterside (WS) end. Slide gate on the landside (LS). Concrete headwall, saddle, and apron on the WS end. Pipe discharges into a 5-foot by 5-foot concrete distribution box at the WS toe. [Additional Reference(s): DWR Levee Log, 2005. USACE Sacramento O&M Manual 151, May 1953, (Station 354+96)]. FS Date: 4/30/2013

Inside view of concrete distribution box.

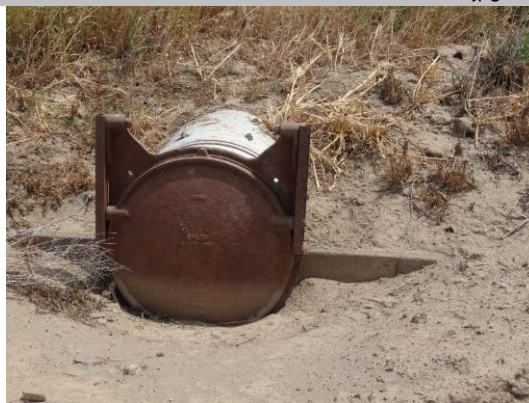
Photo 3 of 3 : UCIP_SP_2018_27793_51513.jpg

Comment Code						
Inspector Comment						
FS_ID:27793 DS_ID:21291 EP_NO: N/A Repair Type: Non-Urgent Crossing Status: Found UCIP Comments: Need to contact owner to remove debris inside concrete distribution box and on slope. This crossing is referenced in the USACE Periodic Inspection as item USACE_CESPK_HON2_2013_p_0244. FIELD_STRUCT_DESC: 30-inch corrugated metal gravity drainage pipe through the levee, 17.3 feet below the crown. Corrugated metal cutoff wall around the pipe at each shoulder. Flap gate on the waterside (WS) end. Slide gate on the landside (LS) end. Concrete headwall at each end. [Additional Reference(s): DWR Levee Log, 2005. USACE Sacramento O&M Manual 151, May 1953, (Station 413+81)]. FS Date: 4/30/2013

Flap gate and concrete headwall visible on waterward side.

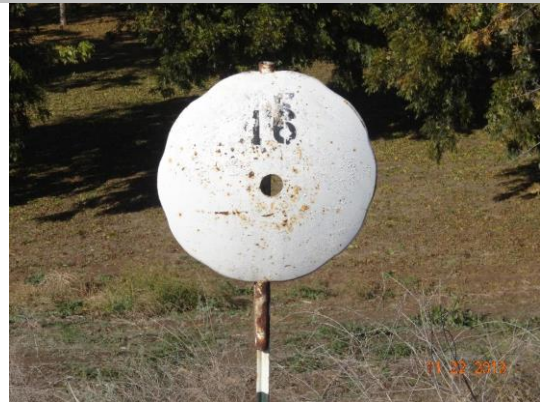
Photo 1 of 3 : UCIP_SP_2018_24832_44705.jpg

Comment Code					
Inspector Comment					
FS_ID:24832					
DS_ID:21295					
EP_NO: N/A					
Repair Type: No Action Needed					
Crossing Status: Found					
UCIP Comments: This crossing is referenced in the USACE Periodic Inspection as item USACE_CESPK_HON2_2013_p_0329.					
FIELD_STRUCT_DESC: 24-inch corrugated metal gravity drainage pipe through the levee, 12.5 feet below the crown. Corrugated metal cutoff wall around the pipe at each shoulder. Flap gate on the waterside (WS) end. Slide gate on the landside (LS) end. Concrete headwall at each end. [Additional Reference(s): DWR Levee Log, 2005. USACE Sacramento O&M Manual 151, May 1953, (Station 515+52)].					
FS Date: 4/30/2013

Marker visible on waterward shoulder, crossing is referenced as No. 16.

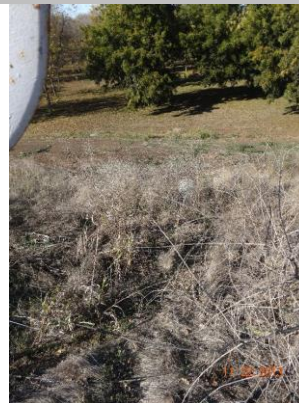
Photo 2 of 3 : UCIP_SP_2018_24832_44704.jpg

View of waterward side.

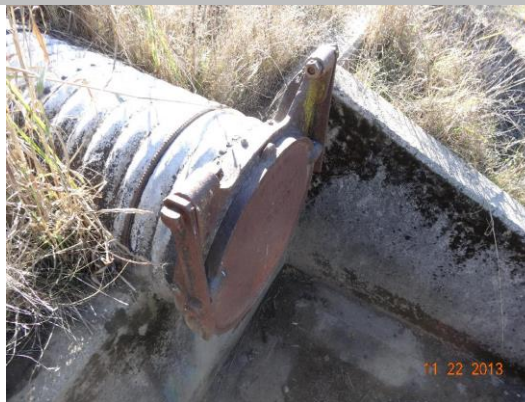
Photo 3 of 3 : UCIP_SP_2018_24832_44703.jpg

View of flap gate located on waterward side.

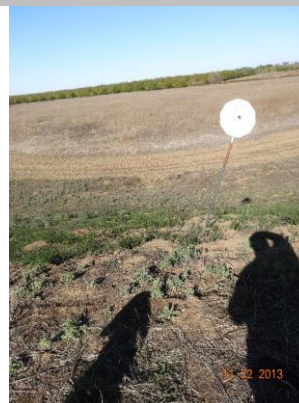
Photo 1 of 3 : UCIP_SP_2018_27775_51473.jpg

Comment Code					
Inspector Comment					
FS_ID:27775					
DS_ID:21296					
EP_NO: N/A					
Repair Type: Non-Urgent					
Crossing Status: Found					
UCIP Comments: Sediment build-up at the inlet--recommend clearing sediment. This crossing is referenced in the USACE Periodic Inspection as item USACE_CESPK_HON2_2013_p_0348.					
FIELD_STRUCT_DESC: 30-inch corrugated metal gravity drainage pipe through the levee, 23 feet below the crown. Corrugated metal cutoff wall around the pipe at each shoulder. Flap gate on the waterside (WS) end. Slide gate on the landside (LS) end. Concrete headwall at each end. Metal marker on the WS shoulder. [Additional Reference(s): DWR Levee Log, 2005. USACE Sacramento O&M Manual 151, May 1953, (Station 551+96)].					
FS Date: 4/30/2013

View of waterward side.

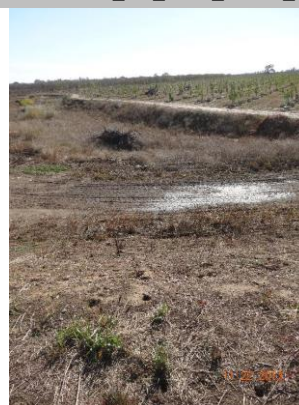
Photo 2 of 3 : UCIP_SP_2018_27775_51472.jpg

View of landward side.

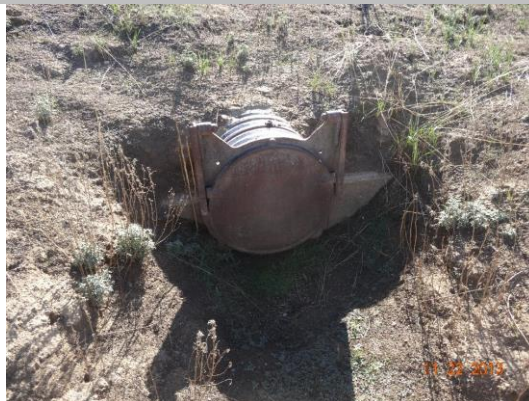
Photo 3 of 3 : UCIP_SP_2018_27775_51477.jpg

Comment Code					
Inspector Comment					
FS_ID:27775					
DS_ID:21296					
EP_NO: N/A					
Repair Type: Non-Urgent					
Crossing Status: Found					
UCIP Comments: Sediment build-up at the inlet--recommend clearing sediment. This crossing is referenced in the USACE Periodic Inspection as item USACE_CESPK_HON2_2013_p_0348.					
FIELD_STRUCT_DESC: 30-inch corrugated metal gravity drainage pipe through the levee, 23 feet below the crown. Corrugated metal cutoff wall around the pipe at each shoulder. Flap gate on the waterside (WS) end. Slide gate on the landside (LS) end. Concrete headwall at each end. Metal marker on the WS shoulder. [Additional Reference(s): DWR Levee Log, 2005. USACE Sacramento O&M Manual 151, May 1953, (Station 551+96)].					
FS Date: 4/30/2013

View of flap gate visible on waterward side.

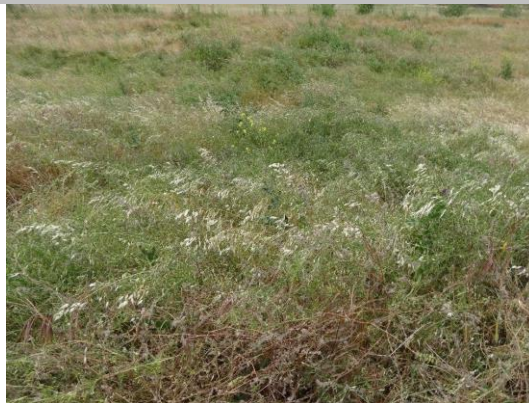
Photo 1 of 3 : UCIP_SP_2018_24768_44450.jpg

View of waterward slope.

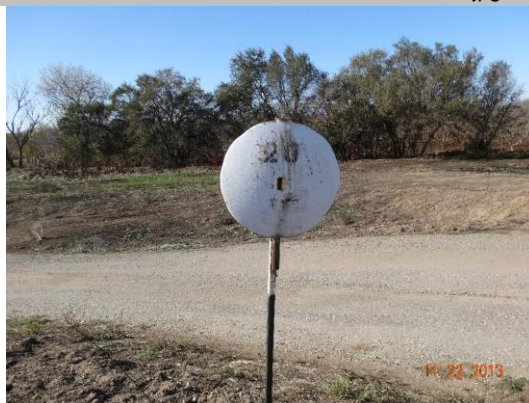
Photo 1 of 3 : UCIP_SP_2018_24769_44454.jpg

Marker visible on waterward side shoulder, crossing is referenced as No. 20.

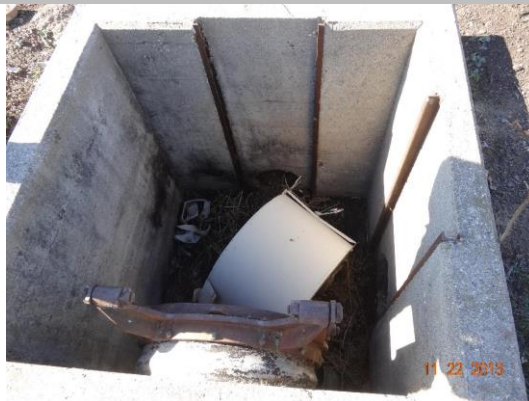
Photo 3 of 3 : UCIP_SP_2018_24769_44452.jpg

FS_ID:24769
DS_ID:21299
EP_NO: N/A
Repair Type: Non-Urgent
Crossing Status: Found
UCIP Comments: Need to contact owner. Need to clear debris from concrete distribution box on waterward and remove debris blocking landward side. This crossing is referenced in the USACE Periodic Inspection as item USACE_CESPK_HON2_2013_p_0383.
FIELD_STRUCT_DESC: 24-inch corrugated metal gravity drainage pipe through the levee, 12 feet below the crown. Corrugated metal cutoff wall around the pipe at each shoulder. Flap gate on the waterside (WS) end. Slide gate on the landside (LS). Concrete headwall, saddle, and apron on the WS end. Metal marker on the WS shoulder. [Additional Reference(s): DWR Levee Log, 2005. USACE Sacramento O&M Manual 151, May 1953, (Station 582+72)].
FS Date: 4/30/2013

View of concrete distribution box located on waterward side.

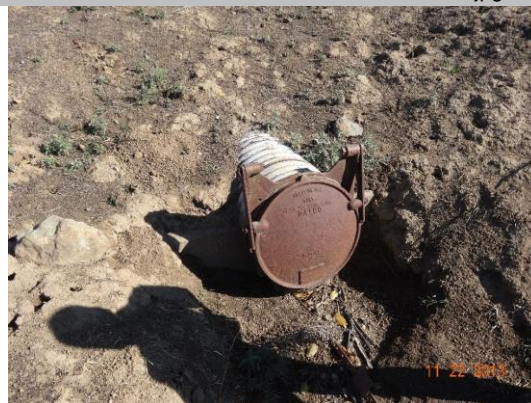
Photo 3 of 3 : UCIP_SP_2018_24835_44725.jpg

Comment Code						
Inspector Comment						
FS_ID:24835						
DS_ID:21300						
EP_NO: N/A						
Repair Type: No Action Needed						
Crossing Status: Found						
UCIP Comments: This crossing is referenced in the USACE Periodic Inspection as item USACE_CESPK_HON2_2013_p_0388.						
FIELD_STRUCT_DESC: 24-inch corrugated metal gravity drainage pipe through the levee, 14 feet below the crown. Corrugated metal cutoff wall around the pipe at each shoulder. Flap gate on the waterside (WS) end. Slide gate on the landside (LS). Concrete headwall, saddle, and apron on the WS end. Metal marker on the WS shoulder. [Additional Reference(s): DWR Levee Log, 2005. USACE Sacramento O&M Manual 151, May 1953, (Station 591+77)].						
FS Date: 4/30/2013

View of flap gate located on waterward side.

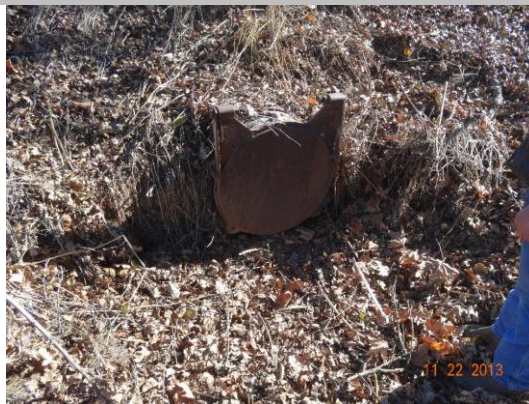
Photo 2 of 3 : UCIP_SP_2018_24840_44752.jpg

View of flap gate located on waterward side.

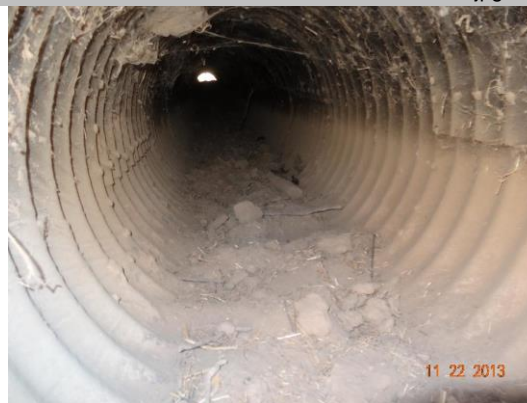
Photo 3 of 3 : UCIP_SP_2018_24840_44751.jpg

FS_ID:24840
DS_ID:21305
EP_NO: N/A
Repair Type: Non-Urgent
Crossing Status: Found
UCIP Comments: Burrow activity--large holes found on landward side. Crossing on landward side is blocked. Recommend clearing headwall and crossing. Need to coordinate with owner to determine status of crossing. If crossing is no longer in use owner will need to contact the CVFPB to comply with Title 23. This crossing is referenced in the USACE Periodic Inspection as item USACE_CESPK_HON2_2013_p_0476.
FIELD_STRUCT_DESC: 24-inch corrugated metal gravity drainage pipe through the levee, 7.5 feet below the crown. Corrugated metal cutoff wall around the pipe at each shoulder. Flap gate on the waterside (WS) end. Concrete headwall at each toe. Saddle and apron on the WS.
[Additional Reference(s): DWR Levee Log, 2005. USACE Sacramento O&M Manual 151, May 1953, (Station 674+73)].
FS Date: 4/30/2013

Internal view of pipe wall from waterward side.

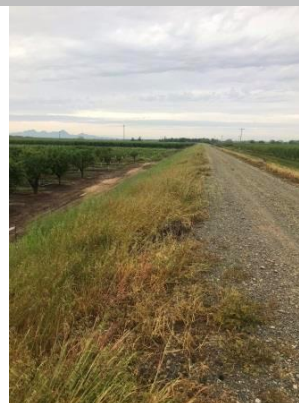
Photo 1 of 1 : SP_2018_RD0010_165_4_20180411_00016.jpg

LM Start	0.00	Rating **	A	Issue No.	4
LM End	2.79	Issue Type +	Ma	Location *	LS
Category	Earthen Levee			GPS Latitude/Longitude	
				Start	End
Item	Vegetation			39.310043 °	39.298575 °
				-121.616328 °	-121.570035 °
DWR ID	DWR_RD0010_03_f_2017_4				
Comment Code					
V1 : Control annual grass and weeds on the levee slopes and easements.					
Inspector Comment					
Annual vegetation is maintained, Spring 2018.

View looking downstream landside where the annual vegetation is maintained, Spring 2018.

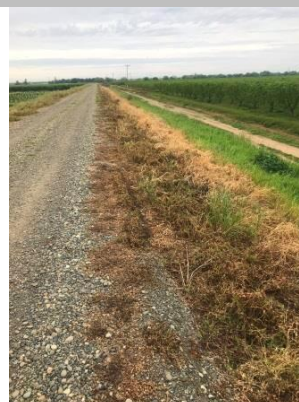
Photo 1 of 1 : SP_2018_RD0010_165_5_20180411_00015.jpg

LM Start	0.00	Rating **	A	Issue No.	5
LM End	2.79	Issue Type +	Ma	Location *	WS
Category	Earthen Levee			GPS Latitude/Longitude	
				Start	End
Item	Vegetation			39.310043 °	39.298575 °
				-121.616328 °	-121.570035 °
DWR ID	DWR_RD0010_03_f_2017_5				
Comment Code					
V1 : Control annual grass and weeds on the levee slopes and easements.					
Inspector Comment					
Annual vegetation is maintained, Spring 2018.

View looking downstream waterside where the annual vegetation is maintained, Spring 2018.

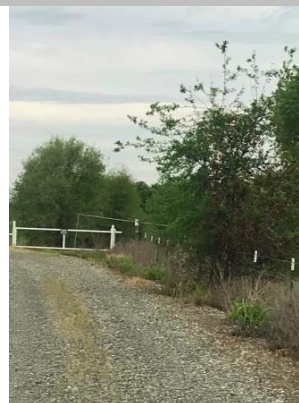
Photo 1 of 1 : SP_2018_RD0010_165_10_20180411_00018.jpg

LM Start	1.10	Rating **	M	Issue No.	10
LM End	1.10	Issue Type +	Ma	Location *	WS
Category	Earthen Levee			GPS Latitude/Longitude	
				Start	End
Item	Trim / Thin Trees			39.306995 °	39.306995 °
				-121.597116 °	-121.597116 °
DWR ID	DWR_RD0010_03_s_2018_10				
Comment Code					
T2 : Thin trees to allow visibility of the ground and room to flood fight.					
Inspector Comment					
Tree needs to be trimmed for access and visibility, Spring 2018.

View looking downstream waterside of a tree that needs to be trimmed for access and visibility, Spring 2018.

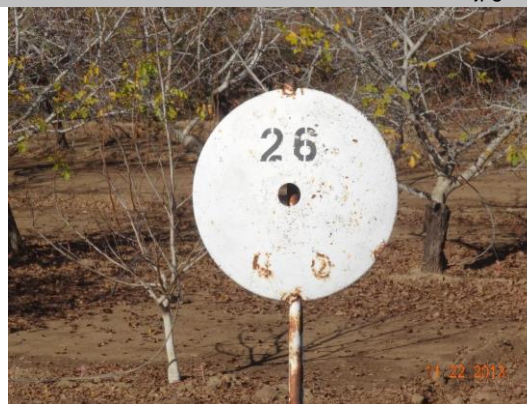
Photo 1 of 3 : UCIP_SP_2018_24842_44764.jpg

Comment Code						
Inspector Comment						
FS_ID:24842						
DS_ID:21307						
EP_NO: N/A						
Repair Type: Non-Urgent						
Crossing Status: Found						
UCIP Comments: Sediment deposit inside pipe--Need to coordinate with owner to determine status of crossing. If crossing is no longer in use owner will need to contact the CVFPB to comply with Title 23.						
FIELD_STRUCT_DESC: 24-inch corrugated metal gravity drainage pipe through the levee, 15 feet below the crown. Corrugated metal cutoff wall around the pipe at each shoulder. Flap gate on the waterside (WS) end. Slide gate on the landside (LS) end. Concrete headwall at each toe.						
[Additional Reference(s): DWR Levee Log, 2005. USACE Sacramento O&M Manual 151, May 1953, (Station 134+06)].						
FS Date: 5/1/2013

Marker visible on waterward side--No. 26.

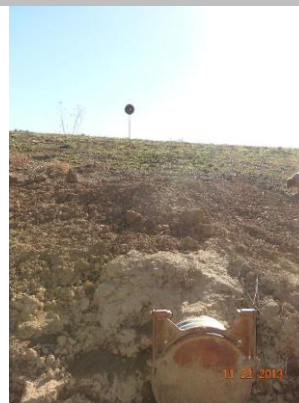
Photo 2 of 3 : UCIP_SP_2018_24842_44762.jpg

View of waterward slope.

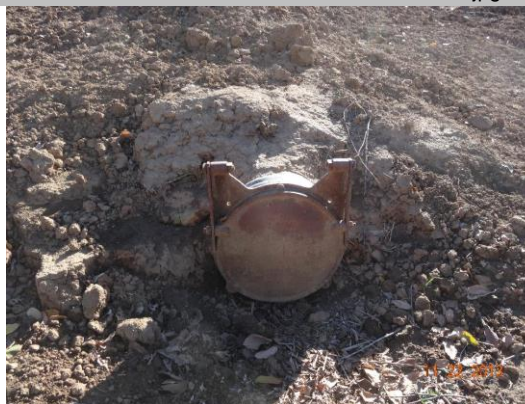
Photo 3 of 3 : UCIP_SP_2018_24842_44763.jpg

View of flap gate located on waterward side.

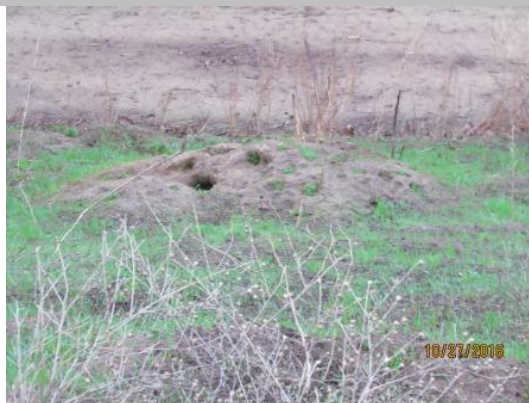
Photo 1 of 1 : SP_2018_RD0010_165_6_20180302_00003.jpg

LM Start	1.72	Rating **	M	Issue No.	6
LM End	1.72	Issue Type +	Ma	Location *	WS
Category	Earthen Levee			GPS Latitude/Longitude	
				Start	End
Item	Animal Control			39.303262 °	39.303262 °
				-121.587680 °	-121.587680 °
DWR ID	DWR_RD0010_03_f_2016_6				
Comment Code					
A3 : No rodents visible, but rodent burrows visible; need to backfill and compact or grout burrows.					
Inspector Comment					
No squirrel activity seen, but rodent holes need to be back filled properly.

View of waterside slope, no squirrel activity seen, but rodent holes need to be back filled properly. Fall 2016.

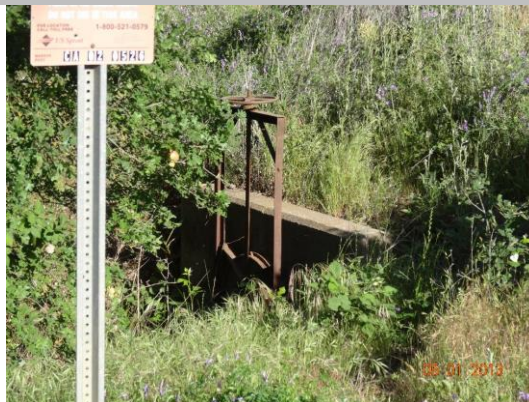
Photo 1 of 2 : UCIP_SP_2018_24883_44820.jpg

Comment Code					
Inspector Comment					
FS_ID:24883 DS_ID:21308 EP_NO: N/A Repair Type: Non-Urgent Crossing Status: Found UCIP Comments: Dense vegetation limits the inspector's visibility to identify signs of pipe failure (leaks) along the slope. Recommend removing vegetation along pipe alignment to conduct proper inspection of structure and appurtenances. FIELD_STRUCT_DESC: 24-inch corrugated metal gravity drainage pipe through the levee, 12 feet below the crown. Corrugated metal cutoff wall around the pipe at each shoulder. Flap gate on the waterside (WS) end. Slide gate on the landside (LS) end. Concrete headwall at the LS toe. [Additional Reference(s): DWR Levee Log, 2005. USACE Sacramento O&M Manual 151, May 1953, (Station 192+33)]. FS Date: 5/1/2013

View of slide gate and concrete headwall located on landside side.
